Babytherm 8004/8010
Technical Service Bulletin # 4 A

Re: **Modification of photo-therapy option**

Date: March 8, 2001

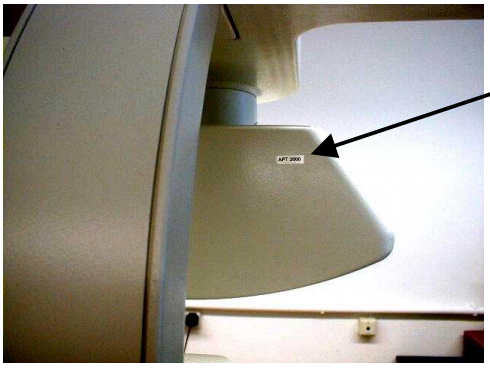
Devices affected: All units Babytherm 8004 and Babytherm 8010 with installed option phototherapy shipped prior March 2001 not labeled with "APT 2000" or "ATP 2000" (Advanced Phototherapy 2000) on the back of the radiant heater:

Solution: Replace plastic cable ties with metal cable ties.
